Chapter 9

Case Studies of Community Water Systems

Emily Jane Davis

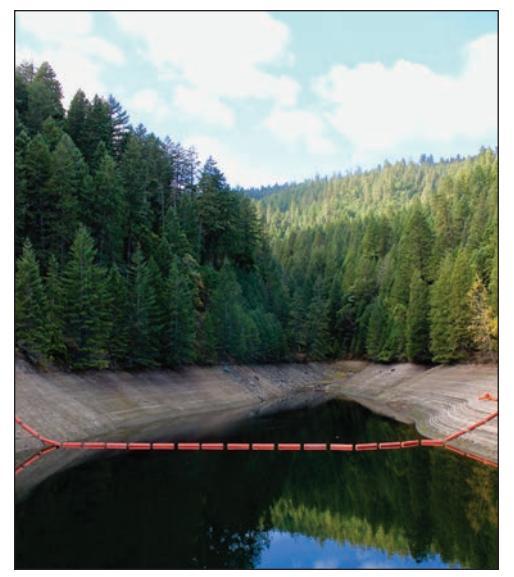
Photo: Emily Jane Davis, © Oregon State University Figure 9-1. Reeder Reservoir in November 2018.

Sedimentation.The Ashland Water Department monitors amount and extent of sediment deposits on the floor of Reeder Reservoir (Figure 9-1), but there is no easy way to remove these. Historical sluicing and some catching in two small

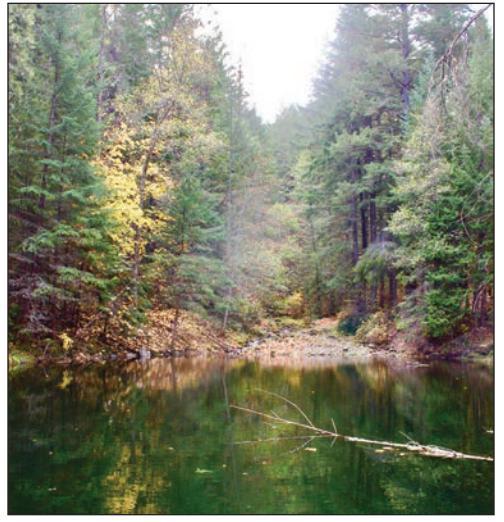
Photo: Emily Jane Davis, © Oregon State University Figure 9-2. Small reservoir above Reeder.

sluicing and some catching in two small reservoirs upstream from Reeder help (Figure 9-2), but sediment deposition is increasing with time.

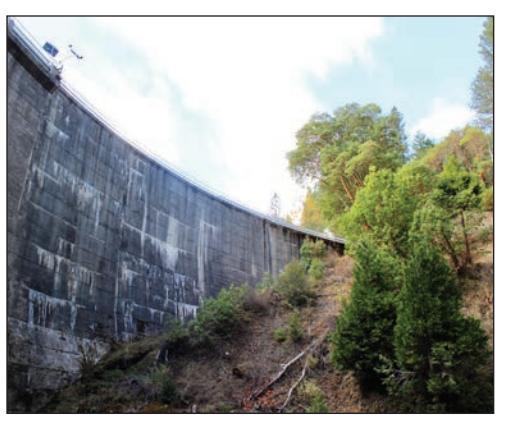
Photo: Emily Jane Davis, © Oregon State University Figure 9-5. Holser Dam.

Diversification of sources. The size of Hosler Dam (Figure 9-5) and the substantial costs of a new dam currently limit the ability of this system to capture more water. The water department has diversified to other backup drinking water sources that are typically used in late summer: Talent Irrigation District (since 1970s; Howard Prairie and Hyatt Lakes) and City of Medford (since 2013; Big Butte Springs or Lost Creek Lake). Talent Irrigation District water is pumped from a ditch to the Ashland plant, while Medford water is transferred via a pipeline.

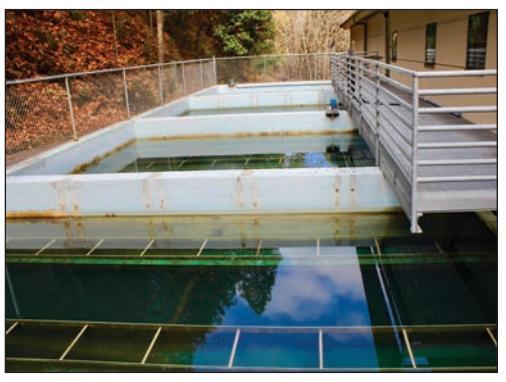
Photo: Emily Jane Davis, © Oregon State University Figure 9-6. Flocculation basin at treatment facility.

Water Department treatment plant is in a narrow, steep-sided canyon of Ashland Creek, where it is threatened by potential landslides, seismic activity and wildfire (Figure 9-6). Major flood events have submerged the facility. A new plant planned and designed for a safer site is slated to become operational in 2021– 2022.

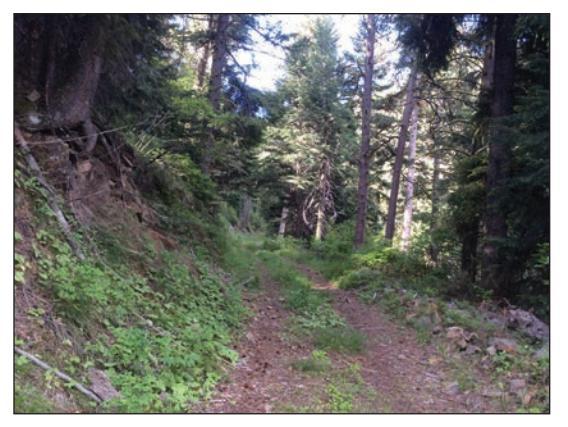
Photo: Emily Jane Davis, © Oregon State University Figure 9-9. Area of unimproved pipeline road.

(NEPA) analysis requirements. Two NEPA projects that have occurred are the Washington/Watershed Project (Environmental Impact Statement, decision signed in 1995) and the Foothills Fuels Reduction Project (Categorical Exclusion, decision signed in 2004). Management actions under these decisions have included commercial thinning, precommercial thinning, whip felling, mechanized slash treatment, hand piling, pile burning and prescribed fire treatments. Thinning has been performed by helicopter and hand. An Environmental Analysis was also completed in 2016, and work has begun to improve the pipeline and road, burying the pipe more deeply and improving the road atop for safer passage of vehicles and equipment (Figure 9-9).

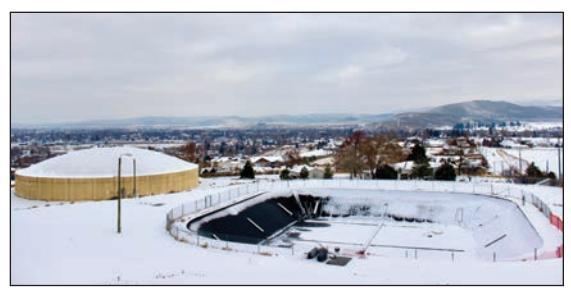
Photo: Emily Jane Davis, © Oregon State University Figure 9-10. Water storage infrastructure.

Future water supply. The water department is building system redundancy and additional capacity from available groundwater sources to help address concerns with future water supply from the source watershed (Figure 9-10). Excess water is available in winter for storage in the aquifer storage and recovery well, but there are challenges in balancing the city's water right for beneficial use of water

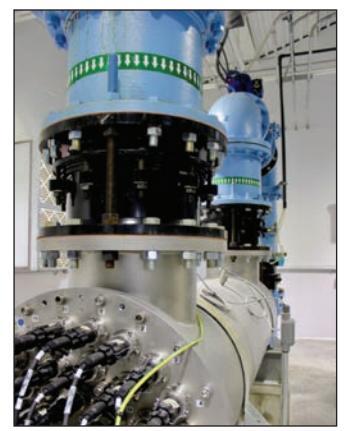
Photo: Emily Jane Davis, © Oregon State University Figure 9-11. A component of the UV treatment system.

Biological contamination. Management of sources of potential biological pollution includes monitoring, fence maintenance, and UV treatment (Figure 9-11). The 2014 Watershed Management Plan states that "increased monitoring, treatment, and preventative measures will be identified to reduce pathogen-inducing conditions. The key is to focus on prevention and reduction of turbidity, organics and pathogens." Monitoring must occur as required by the Surface Water Treatment Rule for surface systems without filtration. Access to the watershed for routine sampling is difficult given restrictions, but downstream sampling also provides data. The water department is also using aerial observation and cameras to monitor containment of cattle off the watershed, and any concentrations of ungulate populations. The water department has also taken infrastructure improvement steps, including the burying of a previously exposed

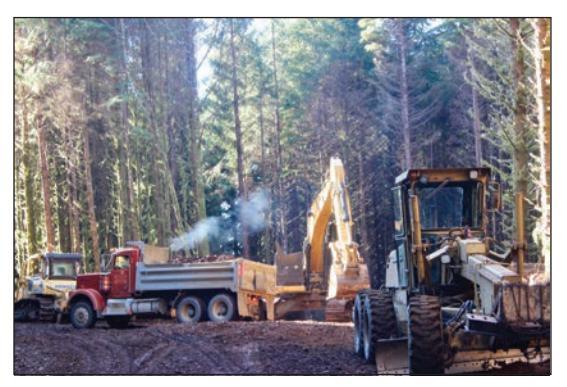
Photo: Emily Jane Davis, © Oregon State University Figure 9-12. Improvement of forest road on Stimson timberland for future harvest operations

Turbidity following forest operations and from forest roads. Clear-cut harvests have not occurred for approximately 40 years in the drinking water source area but are pending in the next two years. Road systems are being improved in preparation. There are 10.6 miles of Stimson roads and .49 miles of Green Crow roads within the Short Creek watershed, and .3 miles of Stimson roads within the Coleman Creek watershed There are two locations where roads on Stimson lands cross perennial tributaries of Short Creek and are of major concern from the perspective of the water district (Figure 9-12).

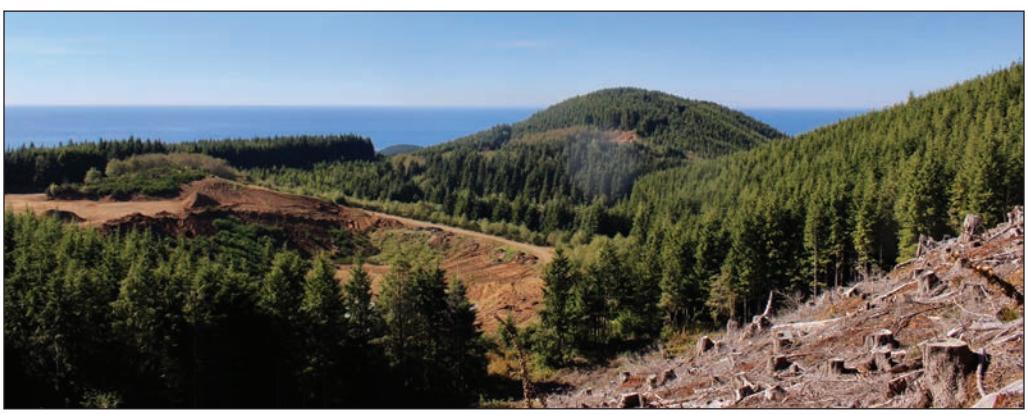
Photo: Emily Jane Davis, © Oregon State University Figure 9-13. Portions of a prior harvest unit and the vicinity of a rock quarry, common activities that may occur in coastal watersheds. Area shown is adjacent to but not within the headwaters of Short Creek.

quarries through discharge or runoff of holding ponds combined with rainfall affected Short Creek and caused a multiday plant shutdown in 2007 (Figure 9-13). Followup inspection from the Department of Geology and Mineral Industries reported no runoff and this pit is now in the process of reclamation.

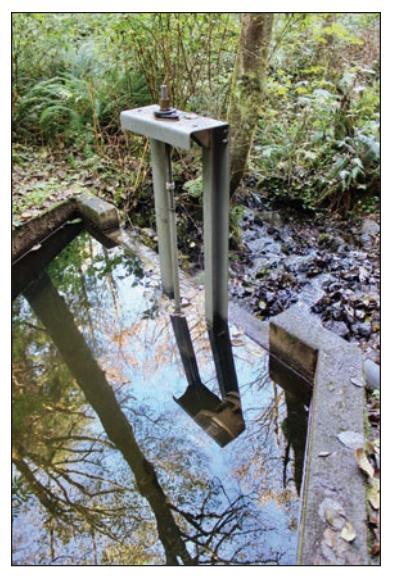
Photo: Emily Jane Davis, © Oregon State University Figure 9-14. Current intake on Coleman Creek for Cape Meares treatment plant.

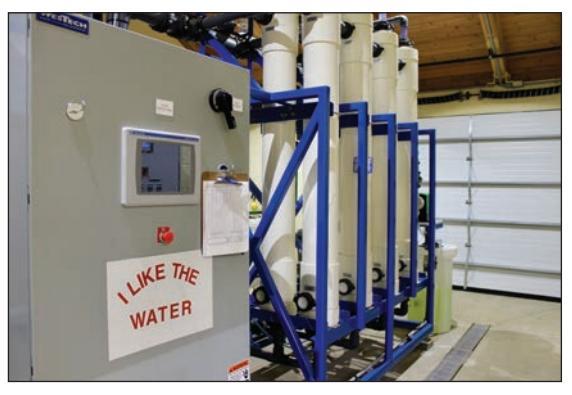
Photo: Emily Jane Davis, © Oregon State University Figure 9-15. Membrane filtration system in the Oceanside treatment plant.

- The district has two treatment plants. The Cape Meares plant can be fed from the Short Creek plant in case of emergency in Coleman Creek. The Oceanside plant has recently carried out \$7.2 million in major system upgrades. Raw water treatment consists of an initial intake through a fish screen, then passage through a membrane filtration system.

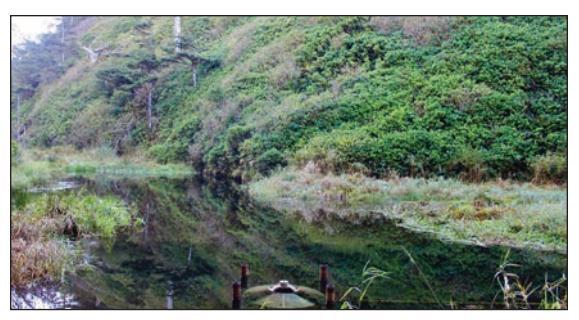
Photo: Emily Jane Davis, © Oregon State University Figure 9-16. Intake on Short Creek for Oceanside treatment plant. Stability of bank slopes in this area is a management concern.

Turbidity. Major seasonal rain events have historically caused high turbidity in both creeks, the holding pond and intake, shutting down the the plant at times. The water district has relocated its Short Creek intake to the center of the creek, which has greatly reduced this issue. Improvements to the Oceanside treatment plant have also increased the capacity of the system to filter sediment (Figure 9-15). However, slope instability and potential landslides near this intake still pose a concern (9-16).

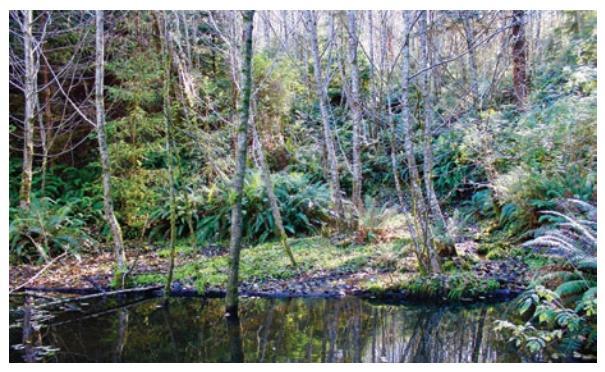
Photo: Emily Jane Davis, © Oregon State University Figure 9-17. Site of potential future improved intake on Baughman Creek.

Diversifying drinking water sources. The water district is working to diversify and increase its future supply by developing a new intake on Baughman Creek (Figure 9-17). Rights to this creek were recently deeded to the district by the Rosenburg family. There is a historic access point and intake site on this creek. The district will be restoring road access to this site by clearing the road footprint and investigating the necessary steps
